UNITED STATES  
**NUCLEAR REGULATORY COMMISSION**  
REGION IV  
1600 EAST LAMAR BLVD  
ARLINGTON, TEXAS 76011-4511

July 18, 2012

**SUBJECT: SAN ONOFRE NUCLEAR GENERATING STATION – NRC AUGMENTED  
INSPECTION TEAM REPORT 05000361/2012007 and 05000362/2012007**

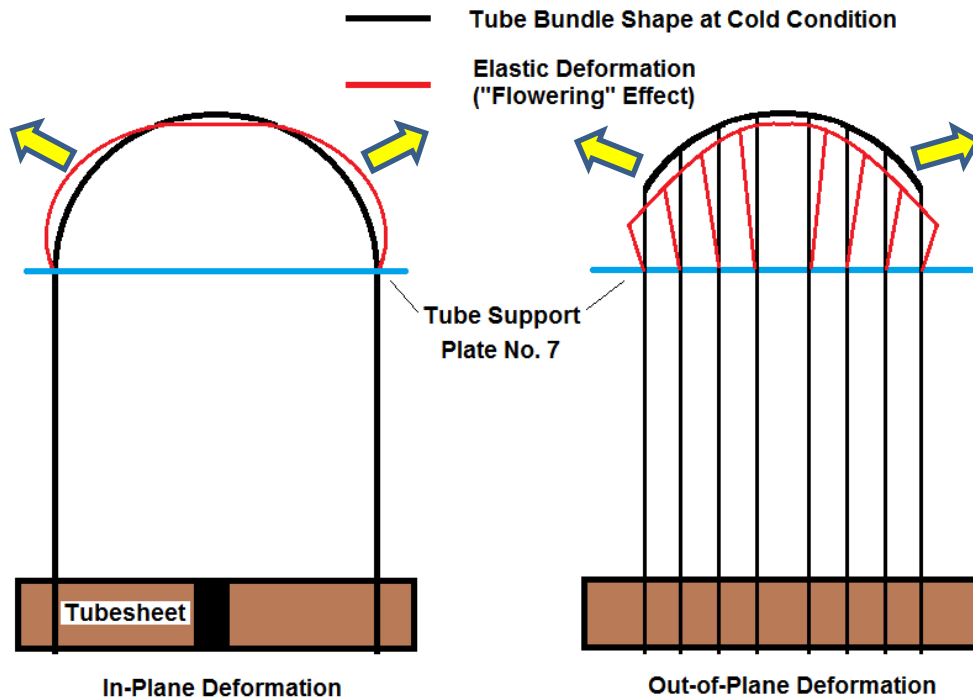
### Description of "Flowering" Effect (Conceptual Drawing – For Illustration Purposes Only)

The failure mechanism model also considered a fluid dynamic effect associated with the spreading of the tubes in the U-bend region during normal operating conditions. This effect was informally referred to as "flowering," due to the characteristic shape in which the tube bundle spreads transverse to the plane of the u-bends at normal operating conditions. "Flowering" was described as the elastic deformation of the anti-vibration bar structure and the tube bundle in the U-bend region, as a result of thermal expansion and fluid dynamic pressure acting on the secondary side of the tubes (see figure below). The deformation caused by the "flowering" effect was believed to result in multiple areas of no contact between the anti-vibration bars and the tubes, which minimized resistance to in-plane motion of the u-bend area of the tubes.

Mitsubishi considered that the collective contribution of the factors described above resulted in conditions in the U-bend that were highly susceptible to excessive tube vibration. The in-plane vibration of the tubes in the U-bend region allowed direct contact between free-span sections of the tubes, resulting in the unanticipated tube-to-tube wear.

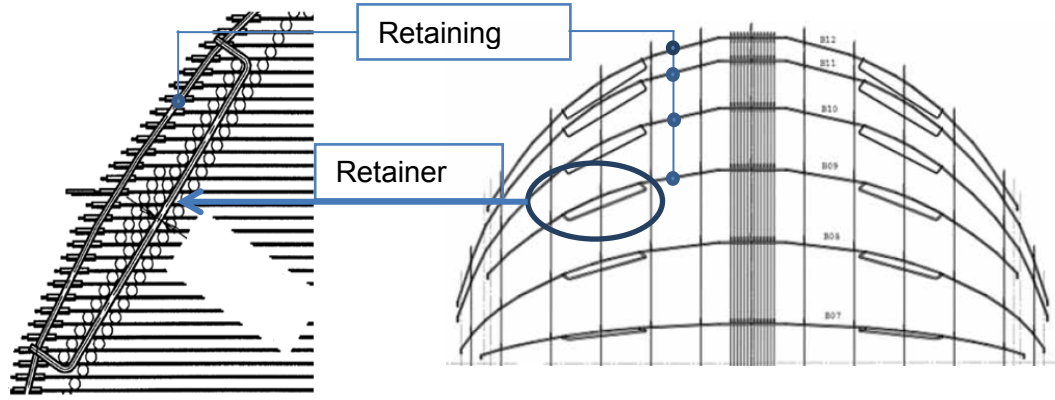
#### Retainer Bar Design and Location of Affected Tubes (For Illustration Purposes Only)

Description: In February 2012, the licensee identified wear indications in Unit 2 replacement steam generators at the tube locations in contact with the retainer bars (see figure below). Some of the indications showed excessive wear with a maximum degradation of 90 percent through wall.

The team identified that the design of the replacement steam generators did not expect any potential vibration concerns in the area of the tube bundle where the retainer bars were located. The basis for Mitsubishi's design philosophy relied on the following factors:

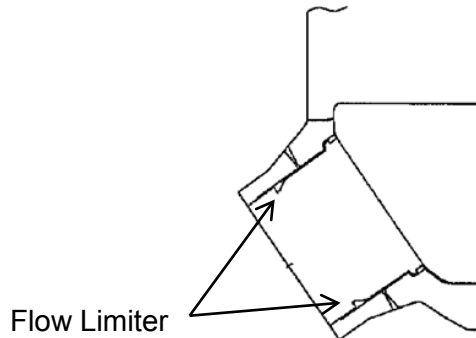
#### Replacement Steam Generator Primary Inlet Nozzle (For Illustration Purposes Only)

- Flow Limiter for Primary Inlet Nozzles** – The replacement steam generators were designed with a flow limiter located in the primary inlet nozzle (see figure below) in order to make the reactor coolant system flow similar to the flow rate of the

original steam generator and not exceed the maximum allowable reactor coolant system flow rate. The licensee's evaluation for the engineering design package determined that although the original steam generators had a number of plugged tubes, the reactor coolant system flow rate of the original steam generators was near the design requirement. Because the replacement steam generators has 377 more tubes than the original steam generators, and contained tubes with u-bends versus "square bends", the pressure drop of the replacement steam generators with no plugged tubes would be much less than the original steam generators resulting in a higher flowrate.

The flow limiter was designed to ensure the total "best estimate" reactor coolant flow rate with the replacement steam generators installed would not exceed 106.5 percent of the design volumetric flow rate of 396,000 gallons per minute at a reactor coolant system cold leg temperature of  $T_{cold} = 540.9^{\circ}\text{F}$ . For Unit 2 replacement steam generators, the flow limiter diameter to nozzle inner diameter ratio was 0.94 while the ratio for Unit 3 steam generators was 0.915 due to Unit 3 reactor coolant pump replacement. The flow limiter dimensions resulted from a scaled model test performed by Mitsubishi and it was designed to be machined as part of the nozzle base metal.

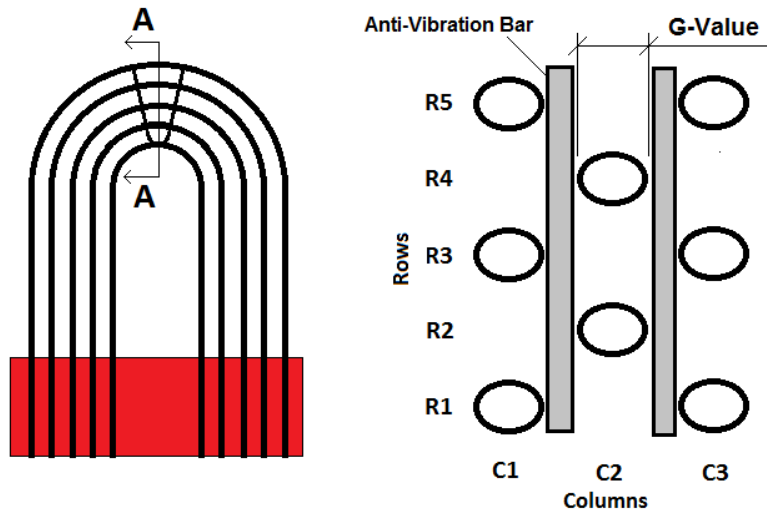
#### Description of G-Value Parameter (Conceptual Drawing – For Illustration Purposes Only)

- Dimensional Controls of Anti-Vibration Bar Structure – According to Mitsubishi's preliminary cause evaluation taking place at the time of this inspection, the controls of critical dimensions affecting the clearances between the tube and the anti-vibration bars were gradually improved throughout the fabrication of the Unit 2 and Unit 3 steam generators. This improvement on dimensional controls was a consideration for the determination of the failure mechanism leading to tube-to-tube wear in Unit 3.

The first dimensional control under consideration was the improvement of tube roundness in the section of the tubes that was bent to form the U-bend shape. During fabrication of Unit 2 steam generator 2E0-89, the supplier of tubular product for Mitsubishi (i.e. Sumitomo), experienced quality issues to meet the G-values established in the design specifications, resulting in a high number of tube rejections. The G-value was a measure of departure from roundness, or "ovality," after the tubes were bent and it was controlled in order to control the gap between tubes and anti-vibration bars (see figure below). The G-values were measured at different locations along the U-bend section of the tubes for a selected number of tubes per row, as established in Mitsubishi's procedure. The acceptance criteria for G-value varied depending on the row where the tubes were installed. The acceptance criteria also remained the same throughout the fabrication of Unit 2 and Unit 3 replacement steam generators.

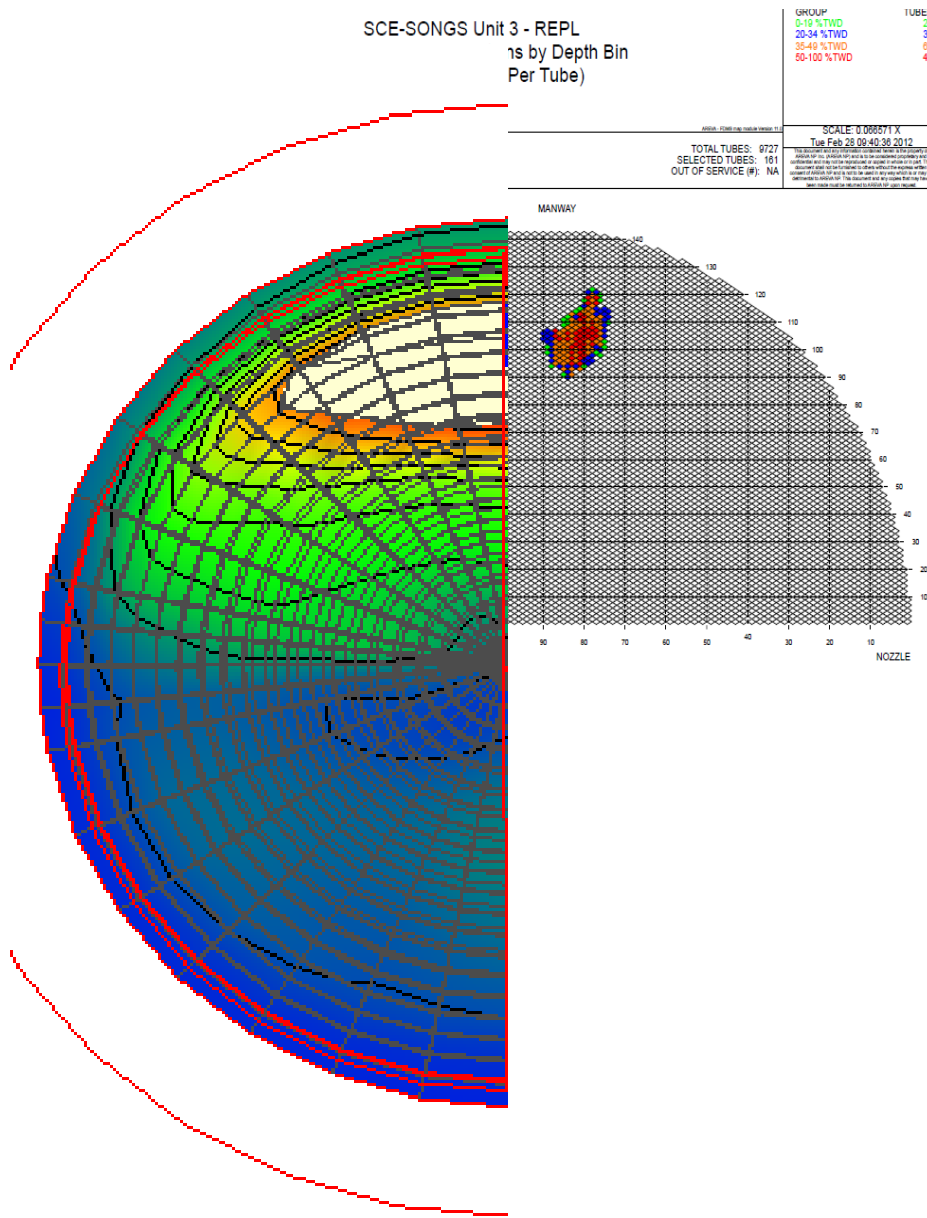
**Figure 5**

The ATHOS code predicted regions of high void fraction and high steam velocities are superimposed with tube-to-tube wear indications from Unit 3 steam generator 3E0-88

The NRC analysis indicated a correlation with the tube-to-tube wear based on a combination of high void fraction and high steam velocities. It should be noted that the traditional forcing function, fluid velocity squared times density, does not show good agreement with the tube-to-tube wear patterns. This indicated that the high quality steam fluid velocities and high void fraction may be sufficiently high to cause conditions in the generators conducive for onset of fluid-elastic instability.
