UNITED STATES  
**NUCLEAR REGULATORY COMMISSION**  
REGION IV  
1600 EAST LAMAR BLVD  
ARLINGTON, TEXAS 76011-4511

July 18, 2012

**SUBJECT: SAN ONOFRE NUCLEAR GENERATING STATION – NRC AUGMENTED  
INSPECTION TEAM REPORT 05000361/2012007 and 05000362/2012007**

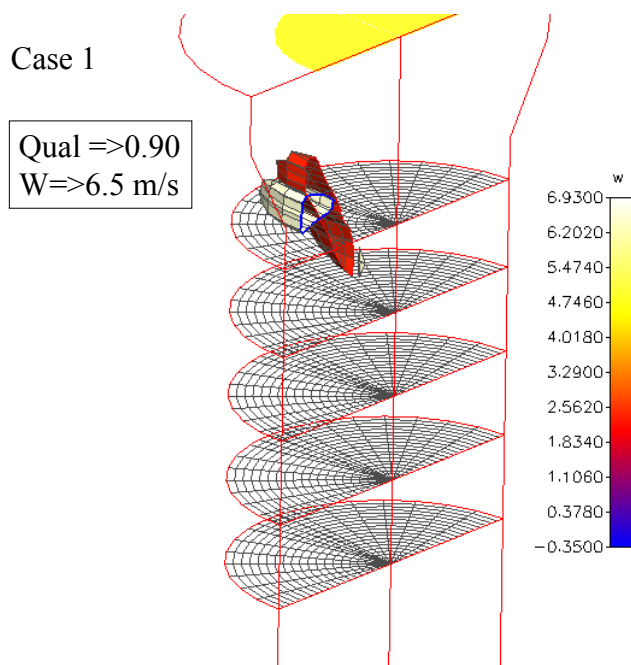
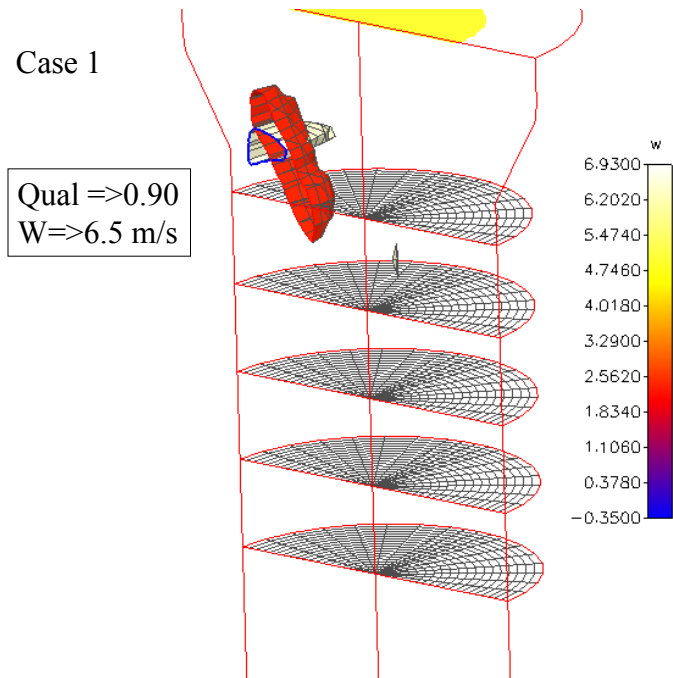
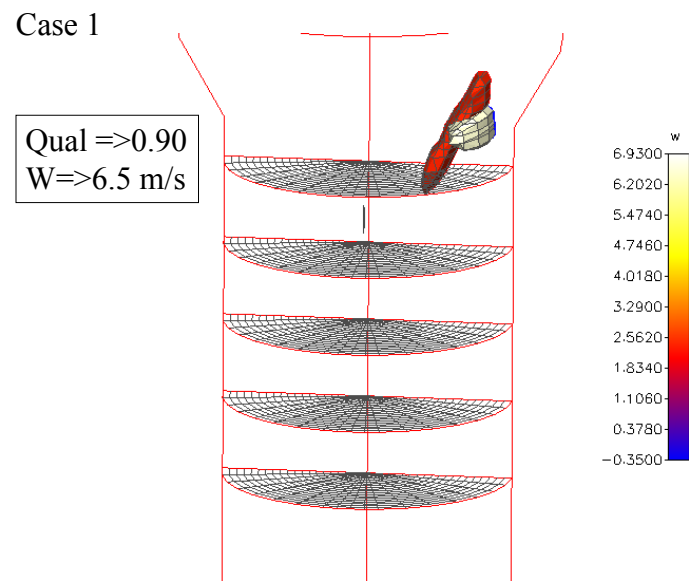
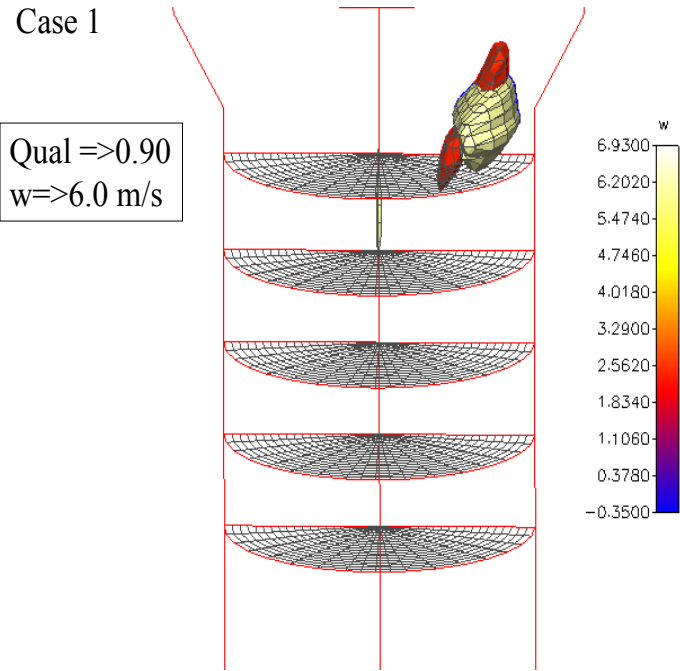
Figures 1 through 4 (different view angles of same results) show results, with low  $T_{hot}$  and low steam pressure and present a 3D isometric encapsulation of steam qualities (red scale) at and above 0.9 (i.e., void fraction > 0.99) and field velocities at and above 6.0 m/sec (white scale).

The ATHOS model results of high steam quality and steam velocity closely align with the area of concern (tube-to-tube wear) in the Unit 3 replacement steam generators. In Figure 5, the code predicted regions of high void fraction and high steam velocities (vertically located z-axis cut at about 20 inches above the 7<sup>th</sup> TSP) are superimposed with tube-to-tube wear indications from Unit 3 steam generator 3E0-88.

The NRC analysis indicated a correlation with the tube-to-tube wear based on a combination of high void fraction and high steam velocities. It should be noted that the traditional forcing function, fluid velocity squared times density, does not show good agreement with the tube-to-tube wear patterns. This indicated that the high quality steam fluid velocities and high void fraction may be sufficiently high to cause conditions in the generators conducive for onset of fluid-elastic instability.
